# Manhole Inspection Summary

Manhole # S250\_\_018MH

Insp Date: **4/3/08 2:17 PM**

**Location** Address: **CARROLL ST.**

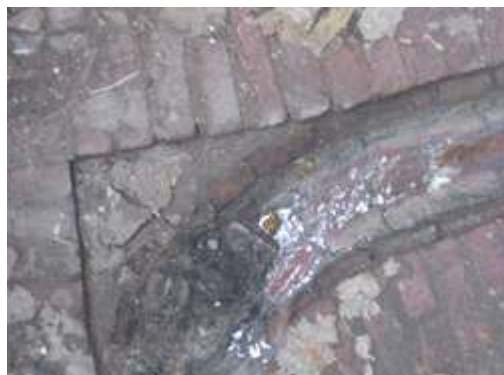
Top View

connection @ 12 is under shelf and unable to be seen from top view (see misc photos)

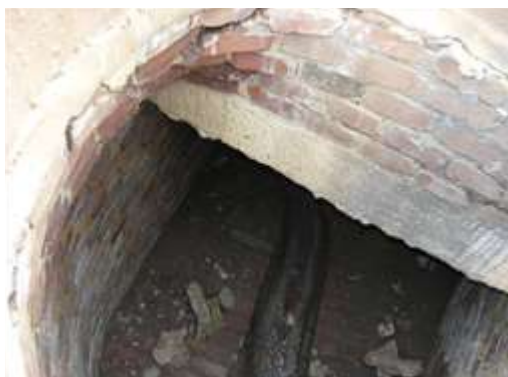
Miscellaneous

MEASURE ISSUE. WALL BLOCKING THE 12 O CLOCK

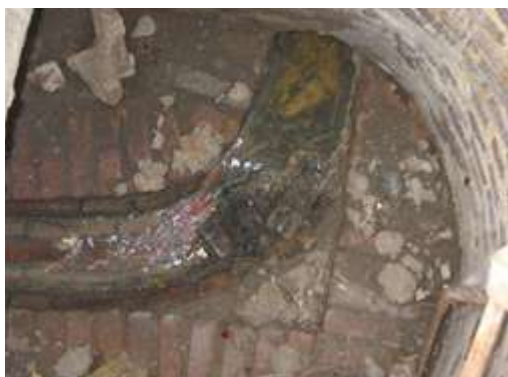
Defect 5

Condition: ☐ Sound ☐ Cracked ☐ Root Intrusion ☐ Deteriorated ☐ Leaks ☒ **Debris**

channel debris

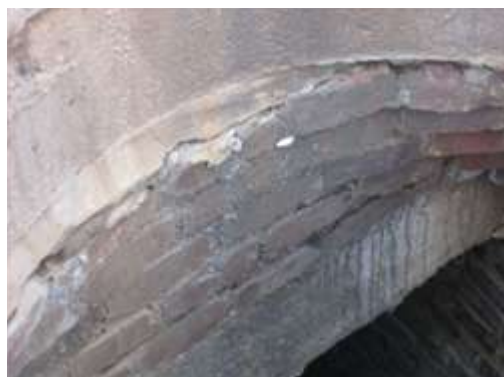
Defect 3

Condition: ☐ Sound ☐ Cracked ☐ Root Intrusion ☐ Loose Brick ☒ **Deteriorated**

Infiltration: ☐ None ☐ Joint ☐ Cracks ☒ **Mortar** ☐ Roots ☐ Wall

chimney deteriorated with signs of infiltration at chimney mortar & corbel mortar, wall

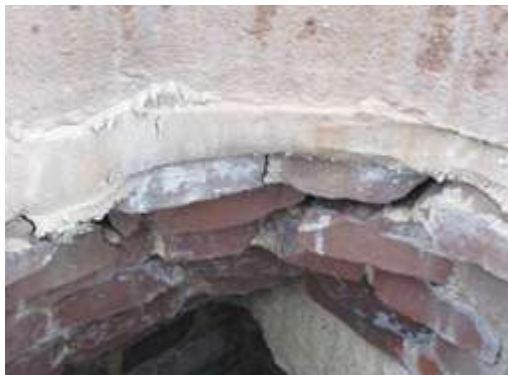
Defect 2

Condition: ☐ Sound ☒ **Cracked** ☐ Root Intrusion ☒ **Loose Brick** ☐ Deteriorated

Infiltration: ☐ None ☐ Joint ☐ Cracks ☒ **Mortar** ☐ Roots ☒ **Wall**

corbel cracked & loose bricks

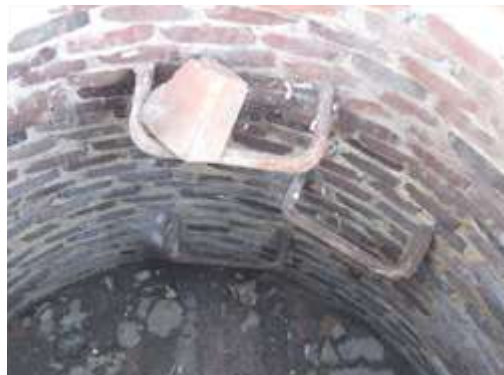
Defect 1

**Steps** Count: **3** Missing: **0** ☒ **Corroded**

corroded steps

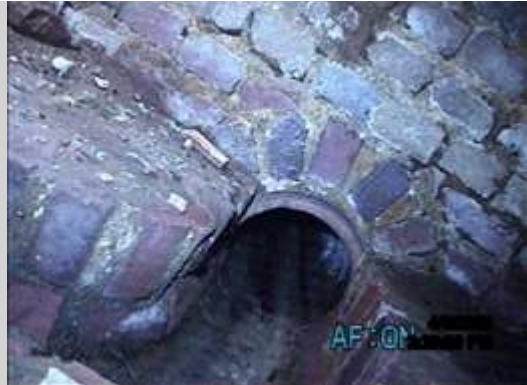
12 O'Clock Outflow

located under MH shelf, best view available
